MOVING IMAGE TECHNOLOGIES INC

Technical Note R000244: IRC-28C Firmware Update Procedure (and workaround) Ver. 2023.05.04

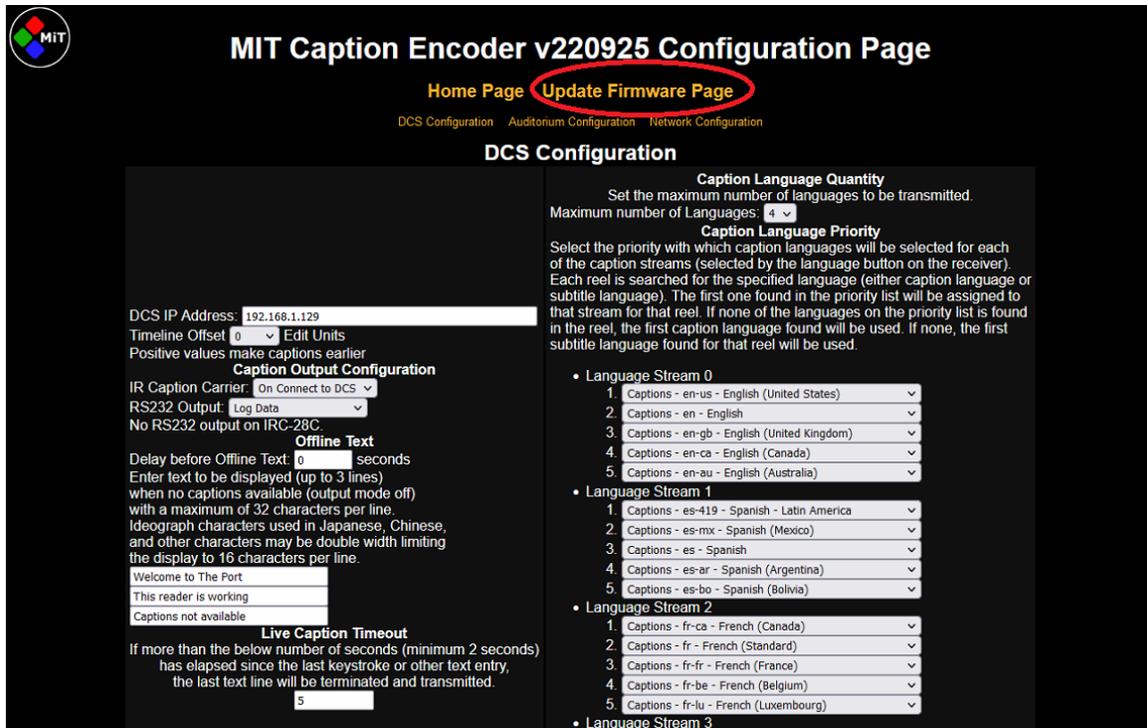
Figure 1:

Updating the firmware is usually quite easy, by simply connecting to the LAN network port from a PC. Navigate to the Firmware Update page in the web UI (see Figure 1), press “Browse,” then navigate to the folder containing the update firmware file, select it, and then click the “update” button.

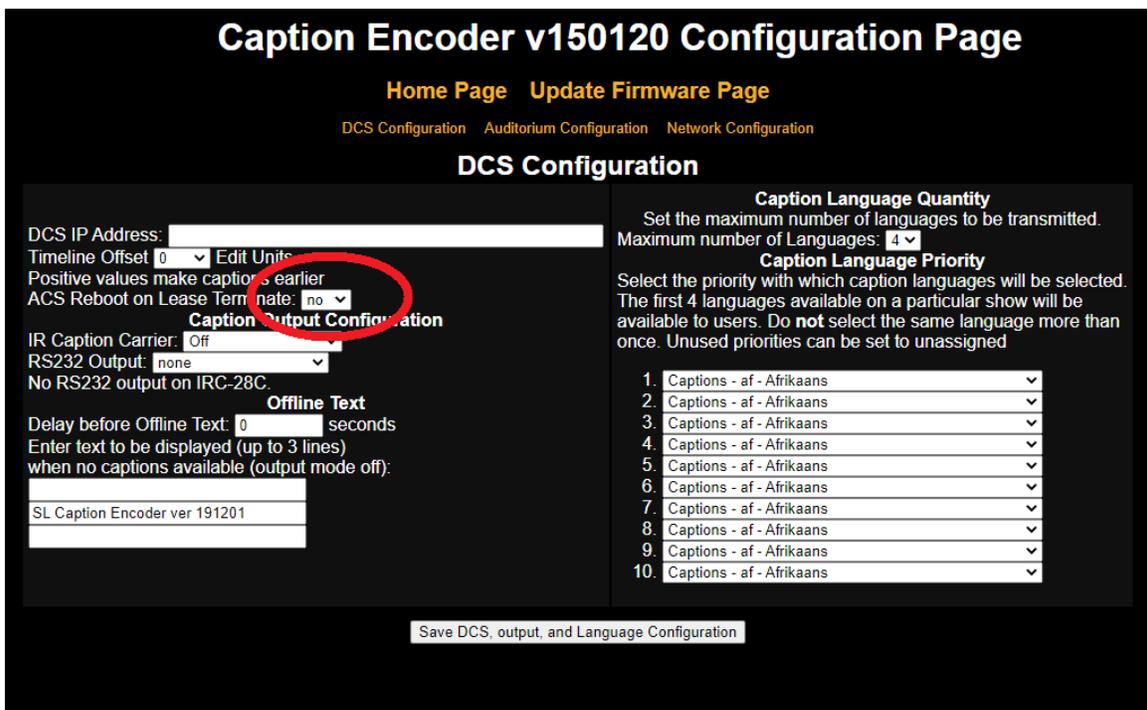
Figure 2: Disable Reboot on Lease Terminate

If you are running an IRC firmware version from 101223 to 150715 and trying to install an update, you may experience a failure of the update because the device may reboot during the update process. In these cases you should go to the Configuration page and turn off the "reboot on lease terminate" option, and try the update again (see Figure 2). If this is not applicable because your unit is already on version 150715 or later, or it fails for other reasons, proceed to the next step.

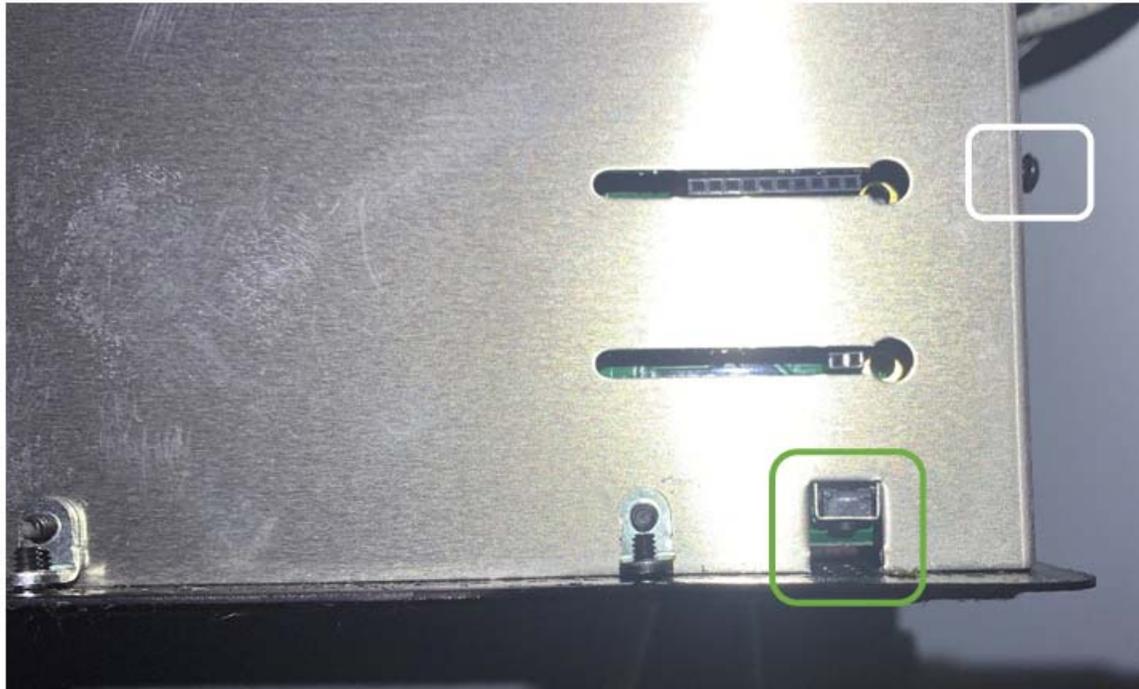
Figure 6

Loosen the four screws holding the protective outer cover on the front of the unit (one of them is highlighted in white in Figure 6), and gently remove the cover. It isn't necessary to remove the screws completely. Be careful not to touch the exposed infrared diodes while the cover is off (See Figure 6).

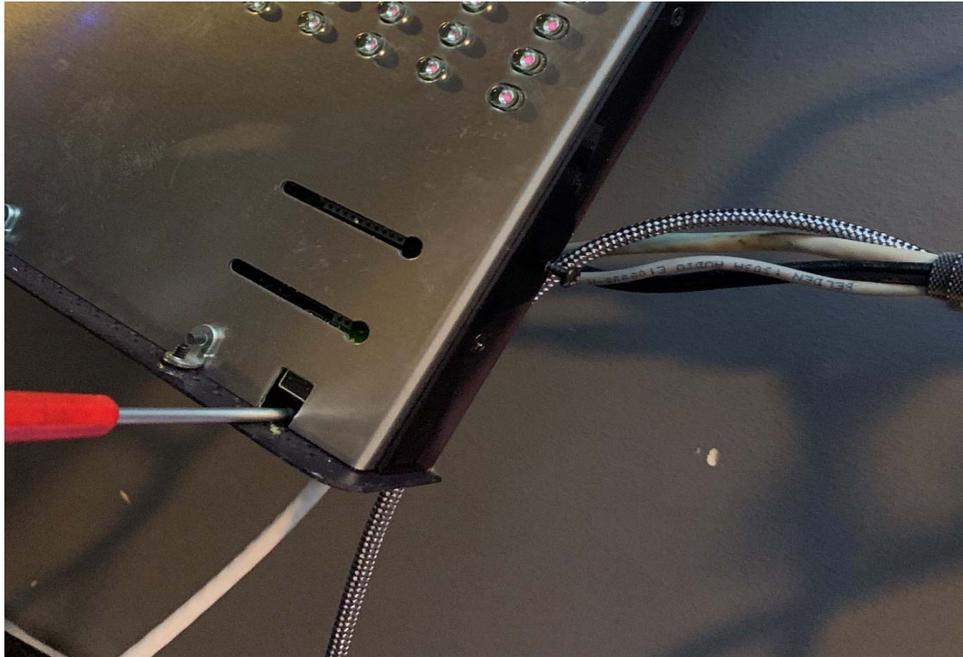
Figure 7: Reset Switch

Unplug the network cable and the green Phoenix connector from the rear of the unit. This will remove power from the unit. Then, using a small flathead screwdriver, gently insert it below the reset button (circled in green in Figure 6). Depress the button and keep it held in. With the button depressed, reinsert the Phoenix connector to power up the unit. Keep the reset button pushed down for 30 seconds, then release (see Figure 7). Be gentle with the screwdriver so as to avoid damaging the switch.

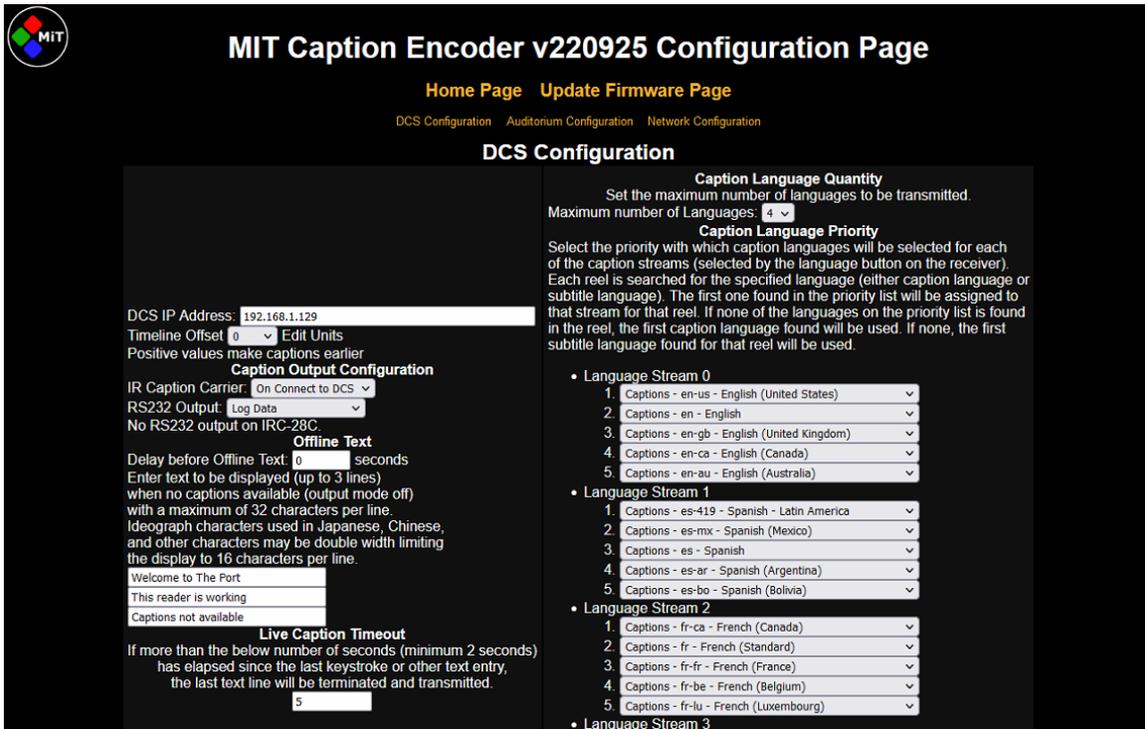
Figure 8:

Now you are ready to try updating the firmware again. From the main Configuration page, select Update Firmware Page. Go to the firmware update page in the web UI, press “Browse,” navigate to the folder containing the update firmware code file, select it, and then push the “update” button. This time the firmware should update and the unit will automatically reboot. If the update was successful, it will be confirmed by the USL/QSC logo and branding on the web UI replaced with MiT (see Figure 8).
