MOVING IMAGE TECHNOLOGIES INC

Technical Note R000322

IRC Life Expectancy and Optimization, & Performance Testing

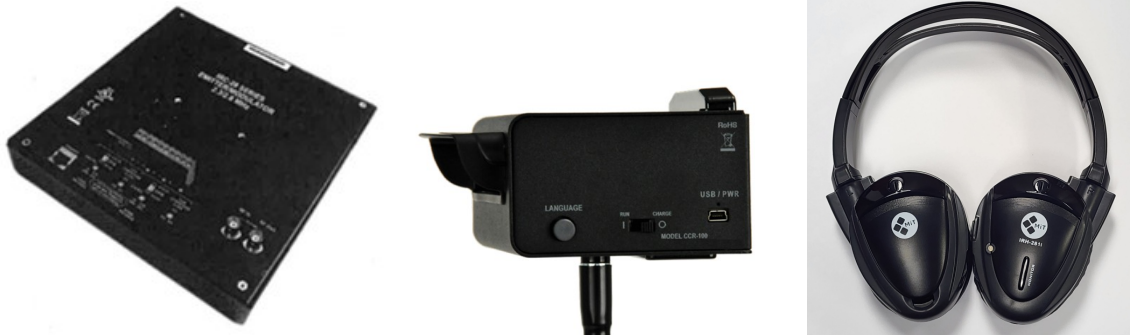
MiT Accessibility Suite: IRC, CCR & IRH

MiT manufactures a suite of products that support services for hearing and vision-impaired individuals. This group of products includes the **IRC** infrared emitter panel, the **CCR** series of closed caption readers, and the **IRH** audio headset. This product line was originally introduced by Ultra Stereo Labs but was subsequently acquired by MiT in 2022.
